THE BOND BETWEEN REPAIR MATERIALS AND CONCRETE SUBSTRATE IN MARINE ENVIRONMENT

K. Behfarnia*, H. Jon-nesari and A. Mosharaf,
Isfahan University of Technology, Isfahan, Iran

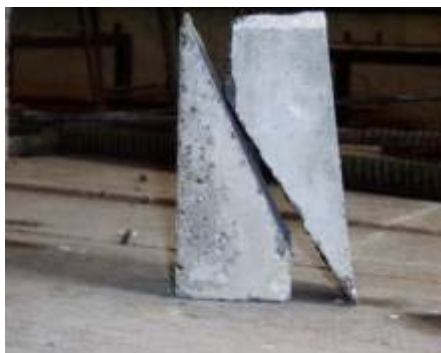
Old concrete samples were made based on BS 6319: Part 4 standard, figure 1. They were cast as 55x100x150 mm prisms and then cut at 30 deg to the vertical axis using a diamond saw. The acid etching method with use of hydrochloric acid was used to prepare the surface of samples.

Figure 1. Concrete samples prepared based on BS 6319: Part 4

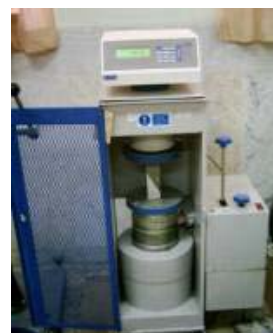
A wide range of test method has been proposed to evaluate bond properties and performance of repair materials in general. The slant shear test has become the most widely accepted test for evaluating the bond of resinous repair materials to concrete. However, there seems to be no standard test for testing the bond to concrete of cementitious and modified cementitious repair materials. To compare the bond strength of repair materials, slant shear test method was used in this work. This method, which puts the bond interface into a combined state of compression and shear is adopted in BS6319: Part4 [1], was used as a test method for evaluating repair materials, figure 2.

Figure 2. Slant shear test

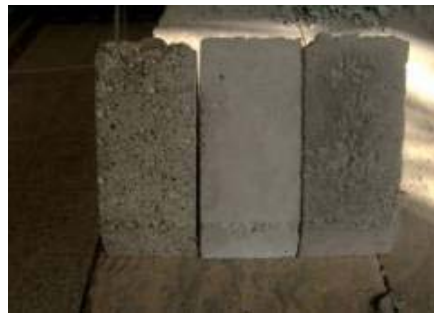
To study the effect of surface preparation method on bond strength, four surface preparation methods, smooth as-sawn (SS), wire-brushed (WB), hand-chiselled (HC), and acid etching (AE) were used to prepare the samples, figure 3. Samples tested by slant shear test method at age of 28 days. The results of bond strength are given in Table 2.

Figure 3. Concrete samples prepared with different surface preparation method

The obtained results show that with use of surface preparation methods the bond strength could considerably be increased. Based on the given results in Table 2, the bond strength of repaired samples is increased 176%, 204%, and 235% with use of WB, HC, and AE methods compare to that of samples with no surface preparation, respectively.
